# FATAL

WORKERS'  
COMPENSATION  
BOARD  
OF BRITISH  
COLUMBIA

POSTER # 97-08

## Do not override safety devices

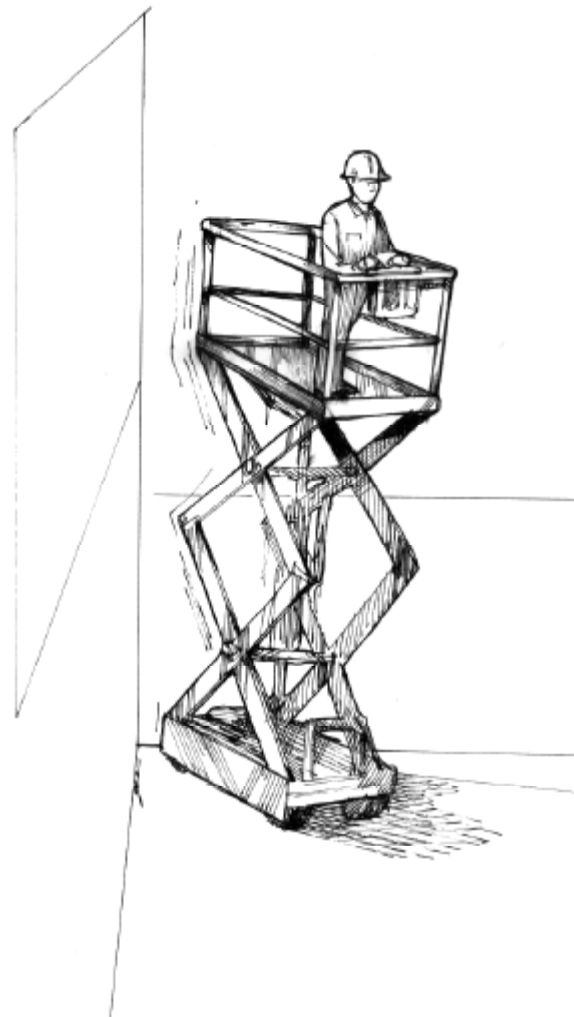
A window washer was killed when the elevated scissor lift he was operating flopped sideways, throwing him to the pavement below. He died shortly afterward from massive head and back injuries.

At the time of the accident, the window washer was repositioning the self-propelled scissor lift. The lift was equipped with an operational tilt sensor that automatically lowers the operator's lift platform when the tilt exceeds three degrees to any side. He was operating the lift on an eight-degree slope, exceeding the slope capacity by five degrees. However, the wires leading to the tilt sensor had been intentionally disconnected, leaving the window washer without any tilt protection.

- Ensure your elevating work platform(s) is equipped with fully functioning tilt sensors.
- Direct and instruct workers in the safe performance of their duties.
- Never override hydraulic, mechanical, or electrical safety devices.
- Maintain and operate elevating work platforms in accordance with the manufacturer's instructions.
- Before operating scissor lifts, check tilt sensors manually to ensure they are functioning.
- Use outriggers, if provided.
